Manhole Inspection Summary

Manhole # S17II_035MH

Insp Date: **3/18/09 9:01 AM**

Location Address: **2400 PRESBURY ST**

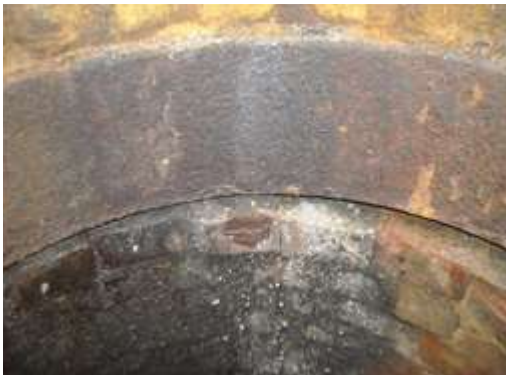
EVIDENCE OF INFILTRATION DUE TO SHEETING FROM ALLEY DRAINAGE

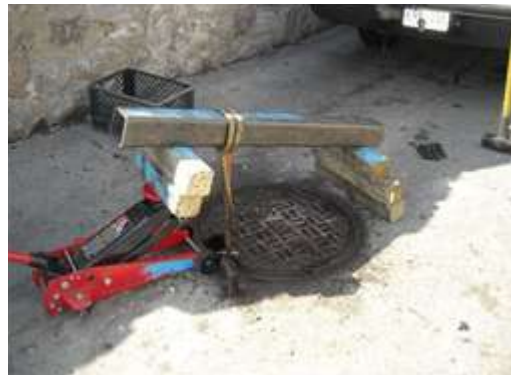
Comments **OBSERVED STUCK AND BROKEN COVER - REMOVED USING JACK AND BOLT METHOD - INSPECTION COMPLETE - REPLACED LID WITH NEW 24" SANITARY.**

BROKE LID WHILE OPENING USING JACK AND BOLT METHOD

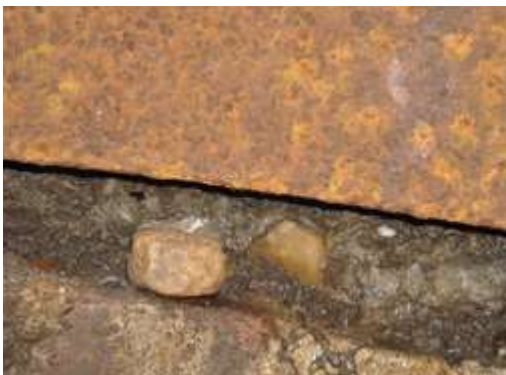
Defect 4

2" GAP BELOW FRAME

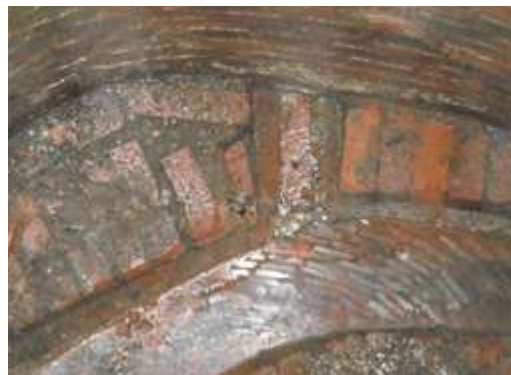
Defect 3

Bench ☒ Exists Material: **Brick** ☐ Parged
Condition: ☐ Sound ☐ Cracked ☐ Root Intrusion ☒ **Deteriorated** ☐ Leaks ☐ Debris

A BRICK HAS BROKEN OFF FROM BENCH AT CORNER OF 9 OCLOCK JUNCTION

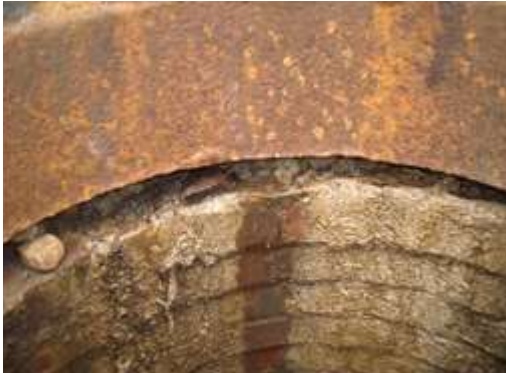
Defect 2

Frame Offset: **1** (in.) Condition: ☐ Sound ☐ Cracked ☒ **Leaks**

EVIDENCE OF INFILTRATION - FRAME
LEAKS

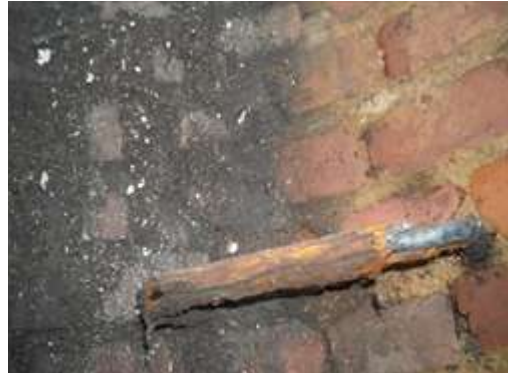
Defect 1

Steps Count: **4** Missing: **0** ☒ **Corroded**

CORRODED STEPS

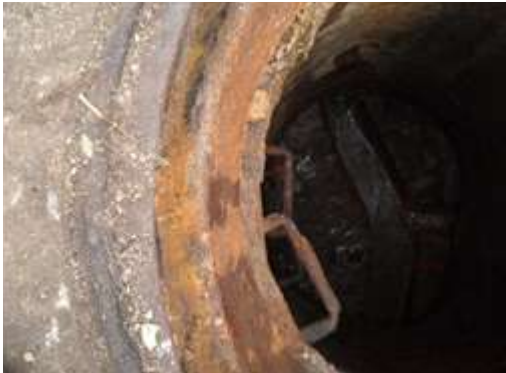
Defect 5

FRAME OFFSET 1"
